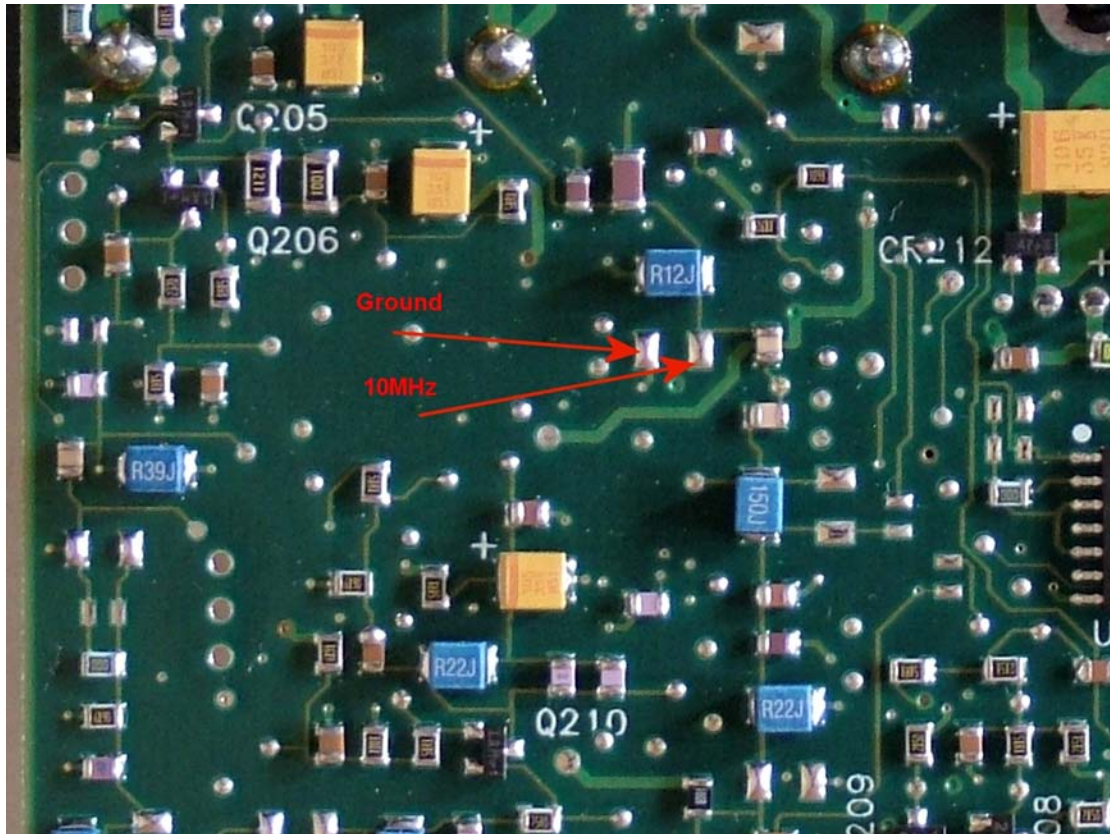
The pad indicated as 10MHz looks to be fed directly from the 10MHz doubler circuit. It has an amplitude of approx 1V P-P and will accept a relatively low impedance load, 1Kohm say, but on a 100MHz bandwidth scope is showing noticeable "ripple".

The junction point of the two capacitors immediately to the right has a higher level signal, approx 2V P-P and seemingly with less "ripple" but needs a high impedance load, 1Mohm loads it significantly.

There seems to be some pretty horrible spikes on the supply rails from the DC-DC regulator, although the Lucent spec claims these to be "very low noise", perhaps feeding from a separate power supply would be interesting.
